Water/NPDES Compliance Evaluation Inspection

**Department of the Army, Baltimore District,
Corps of Engineers, Washington Aqueduct Division
Washington, DC.**

NPDES Permit No. DC0000019

July 12, 2016

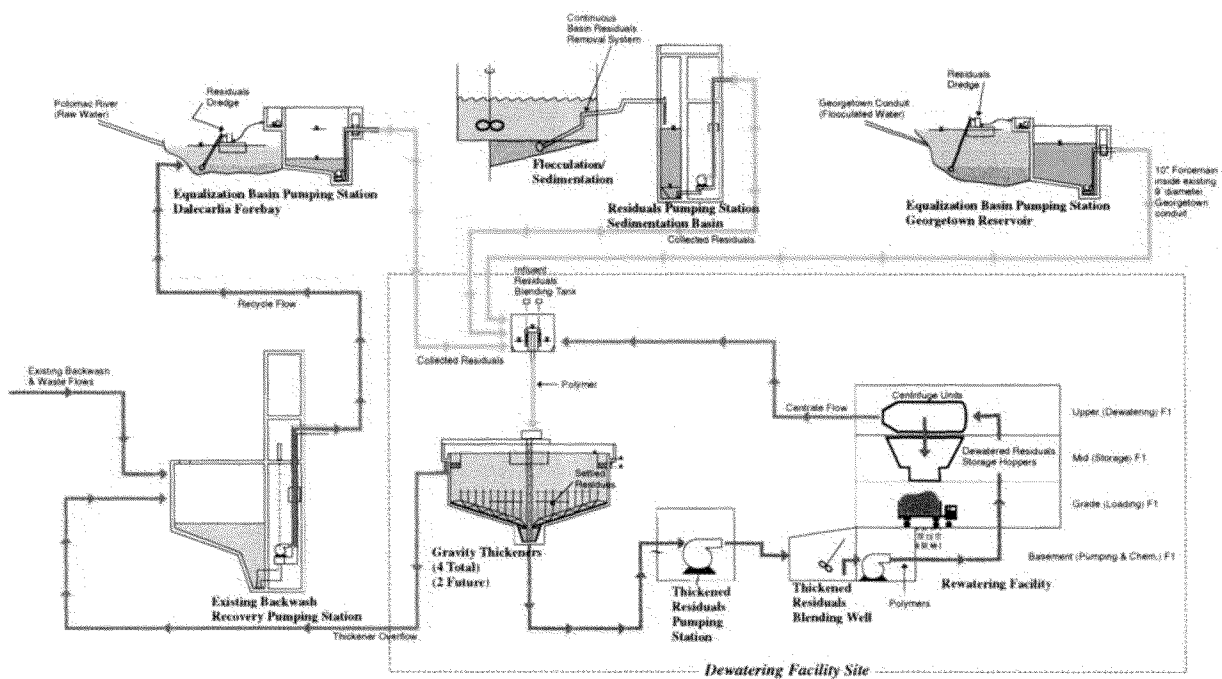
Figure 3: Washington Aqueduct residual management/treatment system

The RPF collects and treats (through a combination of solids concentration and drying processes) all sediments/residues from the sedimentation basins, reservoir dredging, and filter backwash. The facility representative stated that the sediment treatment process involves scraping the sediments from the bottom of sedimentation tanks, or dredging from the reservoirs, followed by pumping them into the Thickener Influent Splitter Chamber (TISC) (also known as influent residuals blending tank (**Figure 3**). At this point, the percent solid is less than 0.5%; the contents of the blending TISC are transferring into four Gravity Thickeners (GTs) where the percentage solid is increased. The residuals from the GTs are subsequently pumped to centrifuges where all remaining water is removed and the dried sediment (cake) is dropped into storage silos and the spent water that was removed returned to the splitter box. After drying, the residuals (cake) are sent to storage bins - ready to be weighed and trucked offsite. The treated residual is about 25 percent solids and is trucked to a landfill for disposal. The Aqueduct pays contractors to transport and dispose of the residuals.

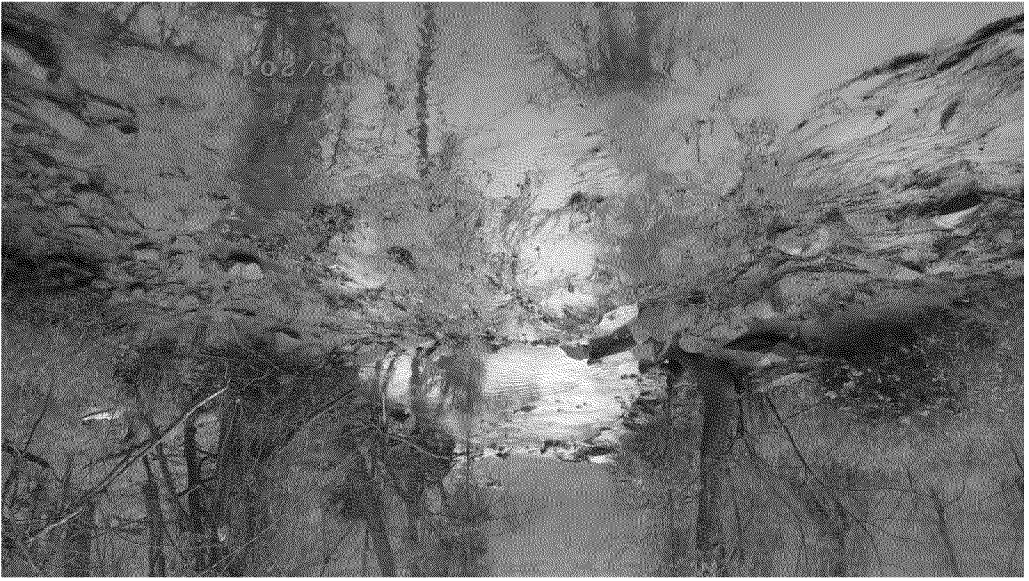
Photo 1. December 2014 bypass

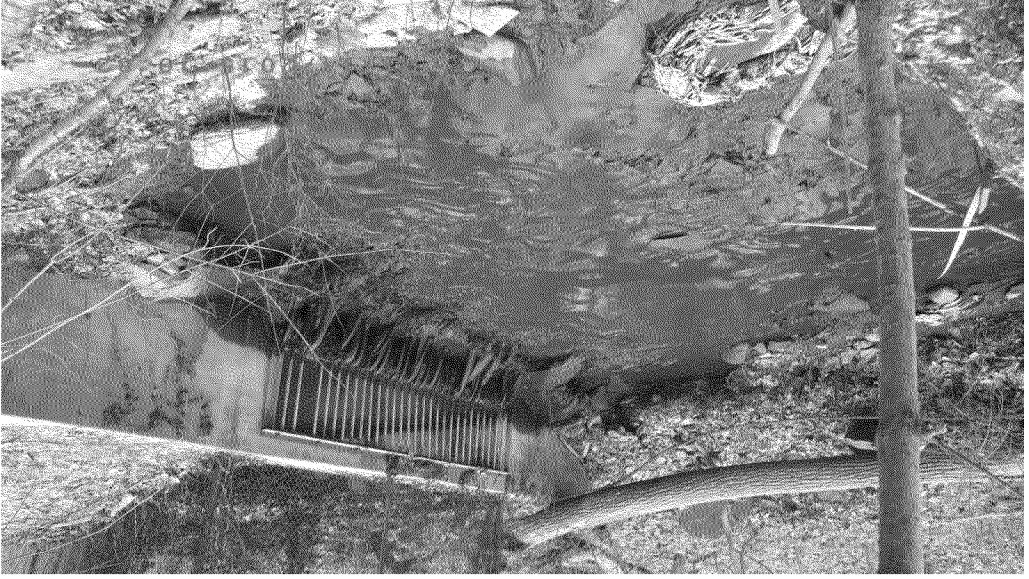
Photo 2. January 2014 bypass

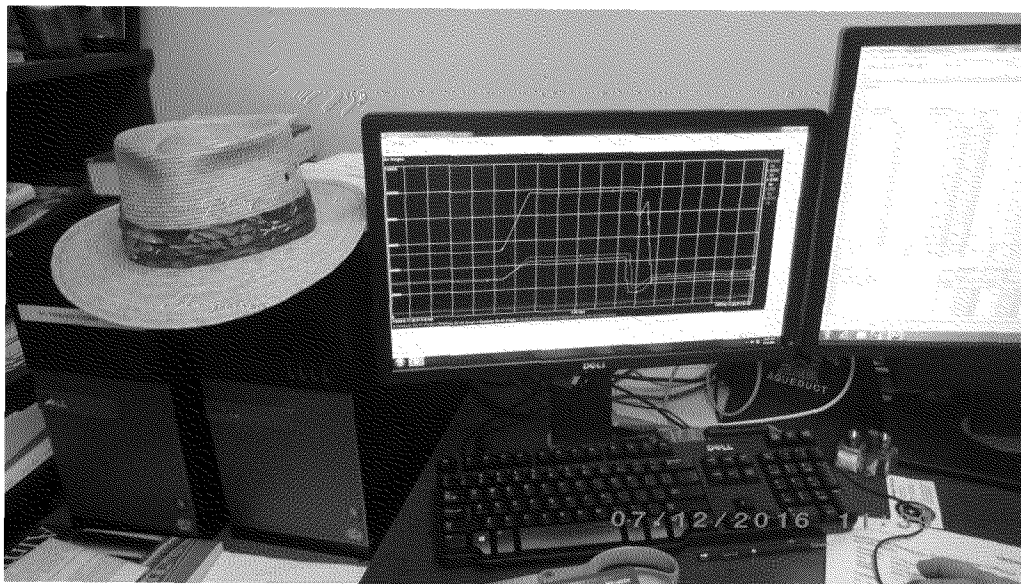
Photo 3. Dredging software showing daily dredging activities

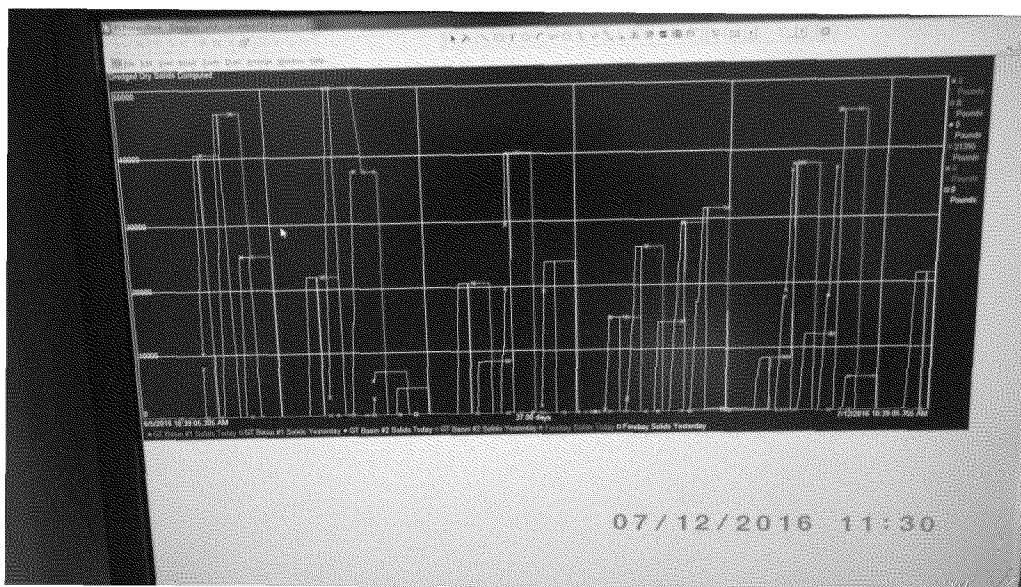
Photo 4. Dredging program showing weekly dredging activities

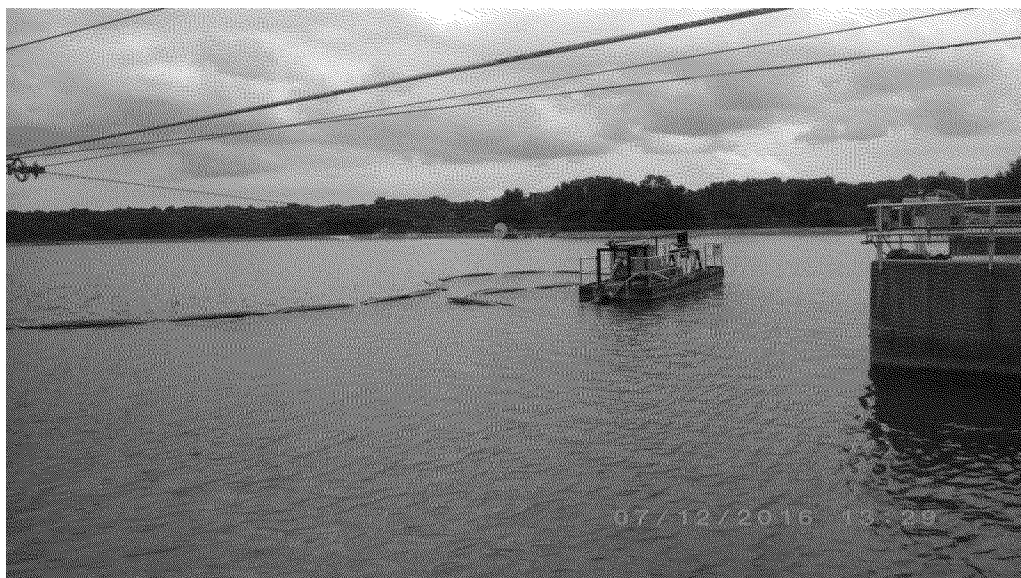
During the 2016 inspection, facility representatives stated operation and maintenance of the RPF and dredging system was moved from the maintenance department to the operations department. The operations department has staff on-site 24 hours a day and can perform both daytime and night time dredging operations increasing sediment removal and improving the effectiveness of the system. The facility is still working to address design issues which do not allow the dredging system to reach the deepest parts of the reservoir. They have hired an independent dredging operation which is scheduled to begin dredging activities in late July or early August 2016. The facility has also installed a real-time monitoring system of sediment levels and removal activities (**Photos 3 and 4**). Inspectors could see on-screen when the dredging operations started and stopped and when residuals were being collected and hauled away. During the inspection, the dredging equipment was being reset and was not seen in operation (**Photo 5**).

Photo 5. Dredging barge not operating, was in the process of being reset

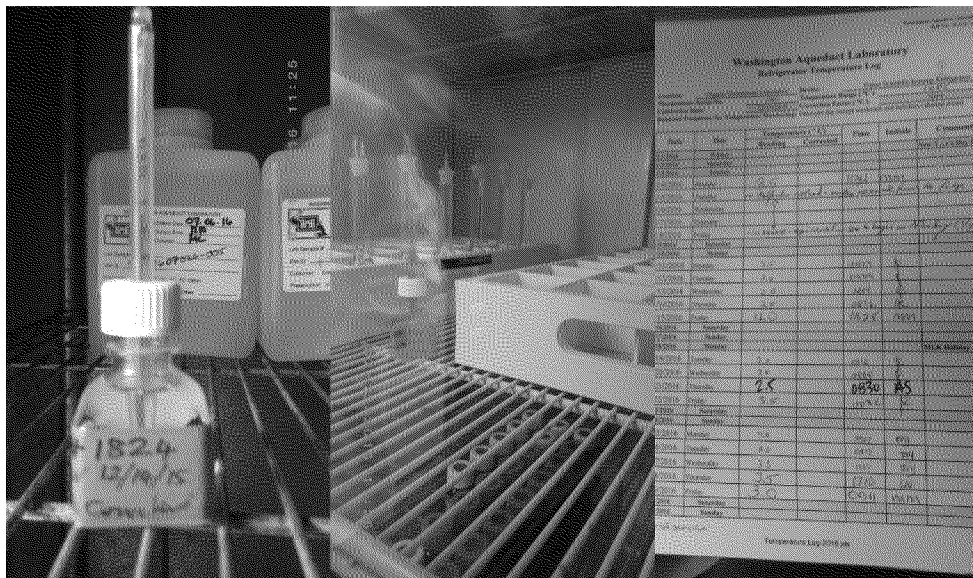
The facility is conducting its self-monitoring program in accordance with Permit Part II, Section C.3, which requires that monitoring be conducted consistent with procedures approved under 40 CFR 136. Raw and processed waters are monitored at different stages of the treatment process. Samples are collected, stored, and processed according to the permit requirements. Refrigerators for sample storage were found operational and at proper temperatures (**Photos 7, 8, and 9**) and logs were properly maintained.

Photos 7, 8, 9. Thermometers in sample storage refrigerators and temperature log

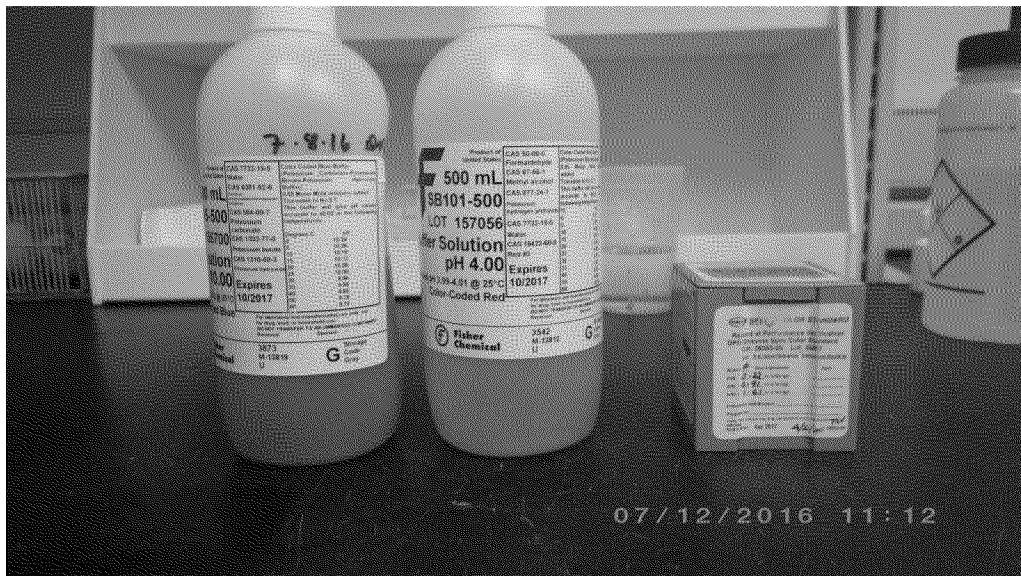
sampled. Sampling at Outfall 002Q is being performed monthly (with weekly internal analysis of perchlorate) instead of quarterly as indicated in the permit. Sample equipment is calibrated on site. Calibration logs (**Photo 10**) and calibrating solutions (**Photo 11**) were found to be up to date and acceptable.

Photo 11. Calibration solutions with expiration dates (pH 7 solution was in an unopened box)

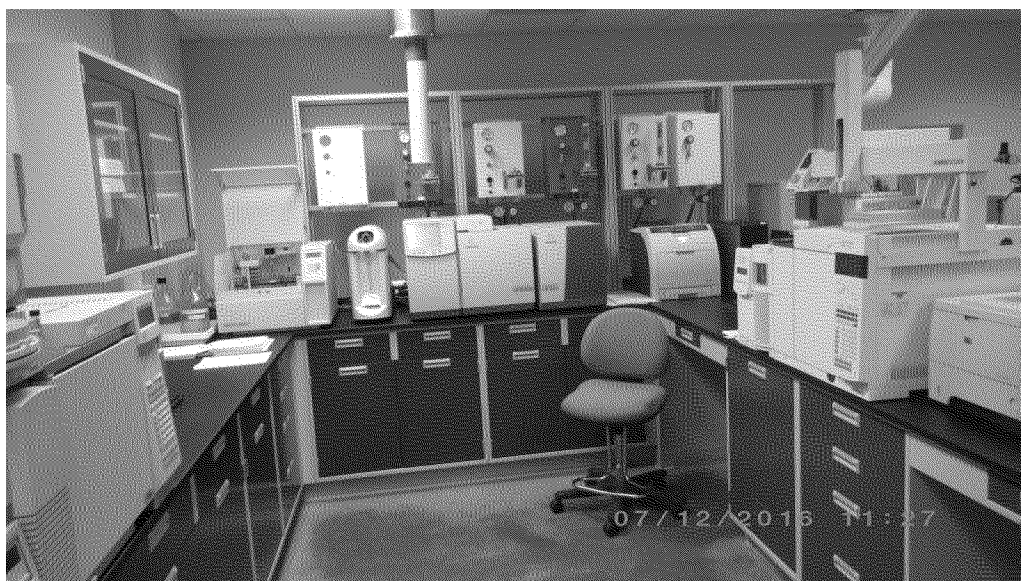
Photo 12. Aqueduct Laboratory

The facility's in-house laboratory is used to monitor effluent samples for all permit parameters (**Photo 12**). The laboratory equipment, calibration records, bench/log books, and lab reports were complete and in order.

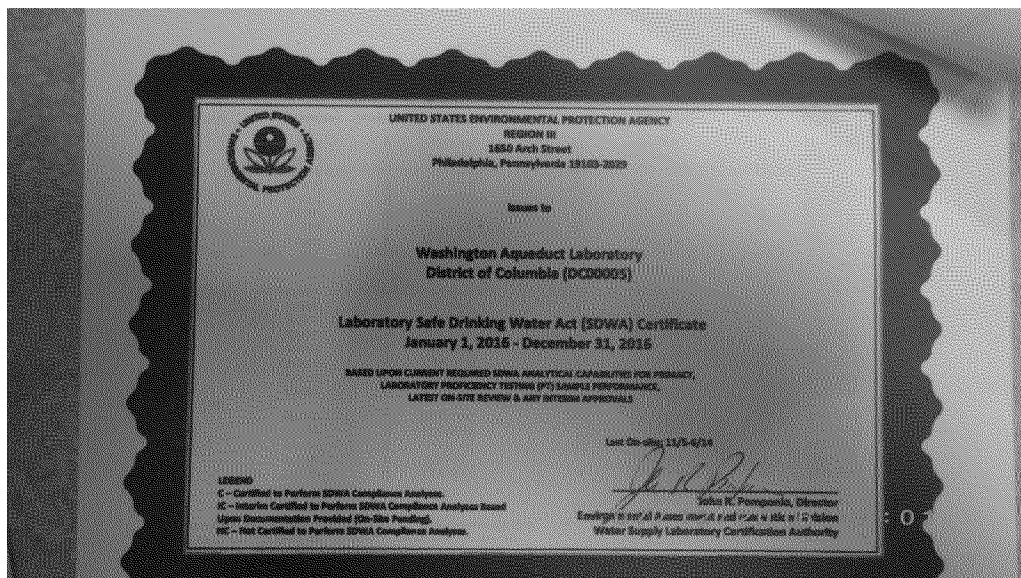
Since the 2012 inspection, the laboratory has updated their Gas Chromatograph and Mass Spectrometer GC/MS (Varian 450-GC / 240 MS) and Ion Chromatograph (Thermo Scientific iCAP-Q ICP-MS) instruments and uses EnviroPro 6.2 to generate lab reports and quality control data. The lab was audited by EPA in November 2014 and also participates and was certified by the EPA DMR-QA Studies (**Photo 13**).

Photo 13. EPA SDWA lab certificate

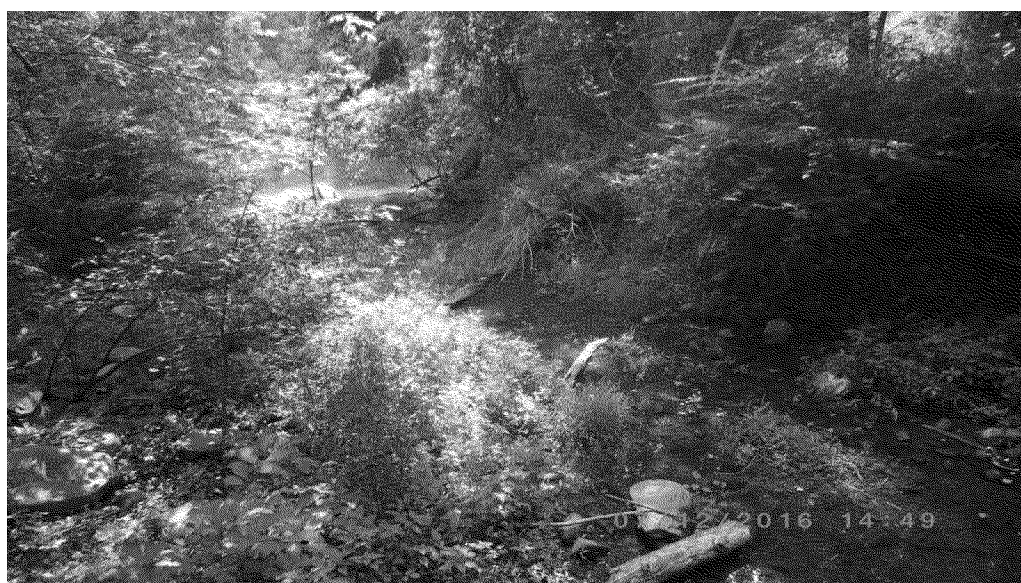
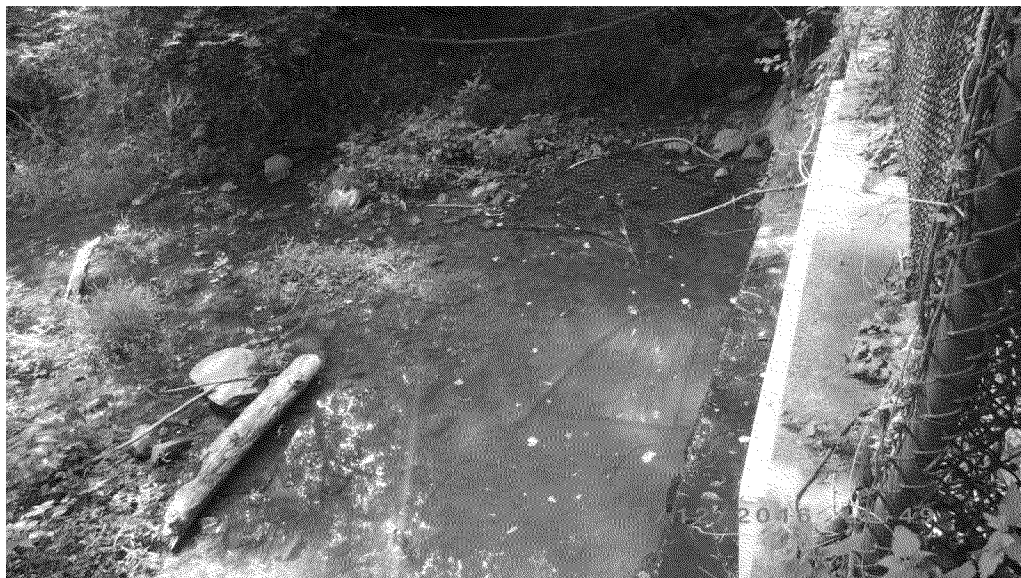
Photo 14. Outfall 004

Both Outfalls 003A and 004A discharge effluent and solids from the Georgetown sedimentation basins to the Potomac River. When Sedimentation Basin No. 1 is cleaned, it discharges through Outfall 004A. When Sedimentation Basin No. 2 is being cleaned, it discharges to both Outfalls 003A and 004A. Outfall 004A was clear at the time of the inspection and appeared to be recovering from the bypasses (**Photos 14 and 15**).
